AL KUT TRAINING ACADEMY
AL KUT, IRAQ

SIGIR PA-06-069
OCTOBER 18, 2006

SUBJECT: Report on Project Assessment of the Al Kut Training Academy,
Al Kut, Iraq (Report Number SIGIR-PA-06-069)

Al Kut Training Academy, Al Kut, Iraq

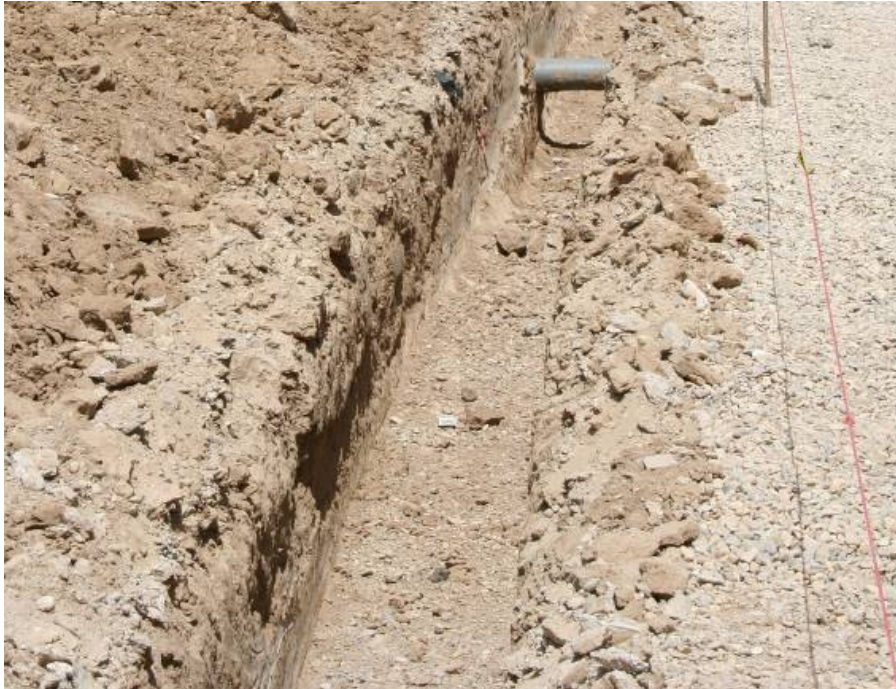
The contractor's original design was a simple septic system comprised of three main tanks. Based on the SIGIR engineer's calculations and a review of the contractor's design, the septic tank capacity varied significantly from actual requirements. In short, the septic tanks installed were substantially undersized. As the population of the academy increased during the early stages of facility operation, the unexpected waste volume and on-site drainage limitations spawned a serious problem. The soil proved to be hard with little drainage capacity and the contractor's design for the septic tank systems did not call for drain fields. During the assessment, the contractor's Program Manager confirmed that a perc test (percolation test) to determine the soil absorption rate for a septic drain field or "leach field" was never conducted. Site Photo 9 shows the nonporous soil.

Site Photo 9. Machine polished trench sidewall soil.

To alleviate the problem over the long term, a SOW modification pending at the time of our site visit called for a buried pressure line connecting the three separate septic tanks in order to pump the effluent underground to the “Dead River”. While original septic tank sizing and placement did not accurately account for soil conditions or daily volume input, the pending SOW, as modified, will alleviate the overflow problem.

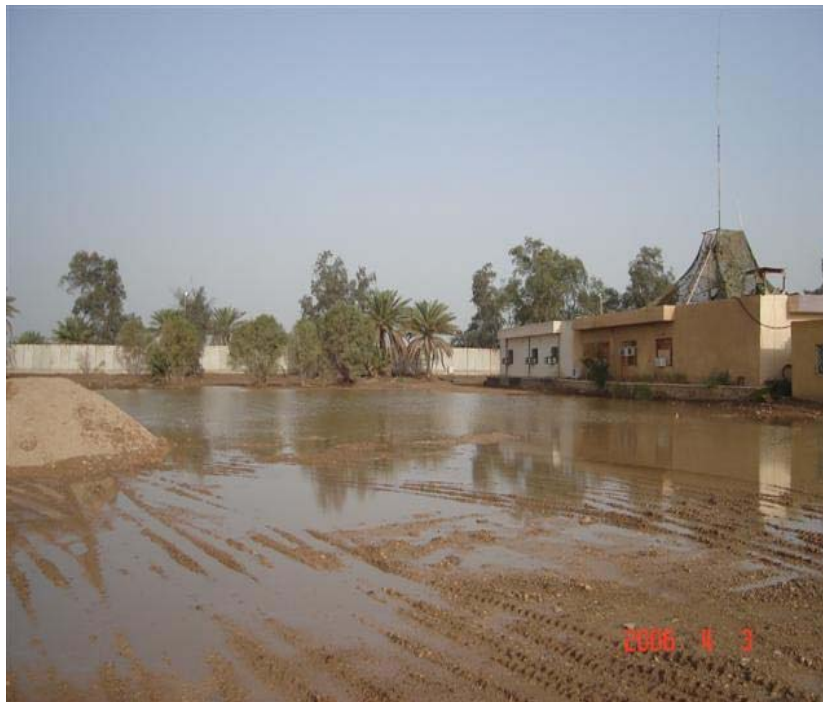
Rather than utilizing a drain field system, the permeable septic tanks were designed to depend on pump trucks to remove excess effluent. However, the contractor's design did not meet requirement because it did not support academy needs in terms of daily volume. When coupled with insufficient soil drainage and limited pump truck capacity, substantial excess waste water overflowed from the septic system. Site Photo 10 shows waste water overflow standing on academy grounds.

Site Photo 10. Standing waste water (Photo courtesy of ECCI).

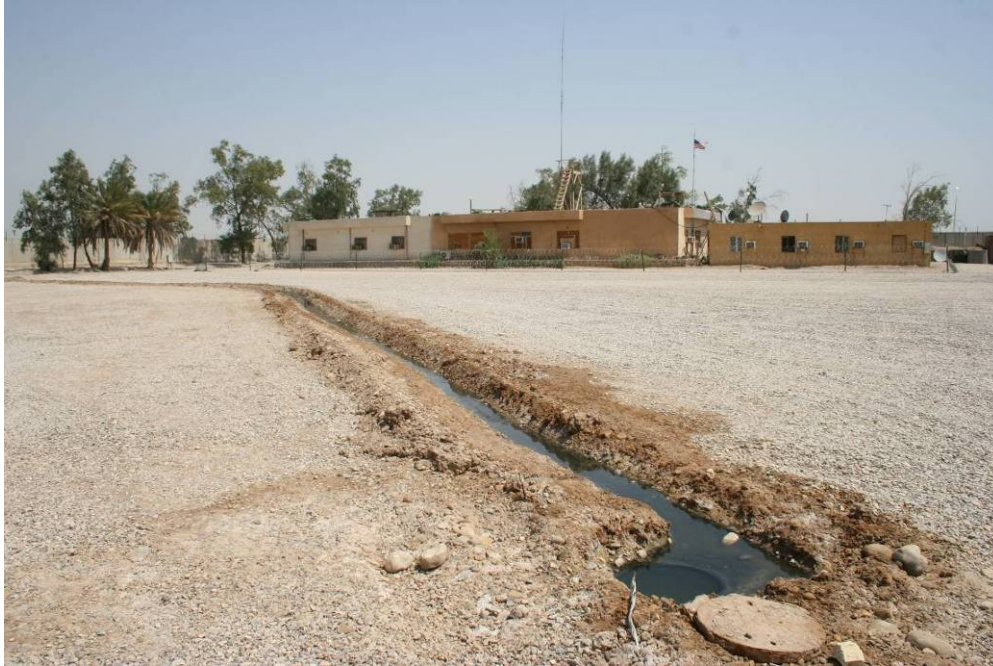
The site assessment disclosed that the main source of the waste water overflow was a septic tank manhole. As a temporary solution to the standing waste water problem, the contractor excavated a surface ditch to drain overflow from the manhole source through the facility to a storm water drainage ditch which empties into a nearby reed filled canal referred to as the “Dead River”. The overflow drainage ditch is shown in Site Photo 11.

Site Photo 11. Surface ditch moving waste water from septic tank manhole to “Dead River”.

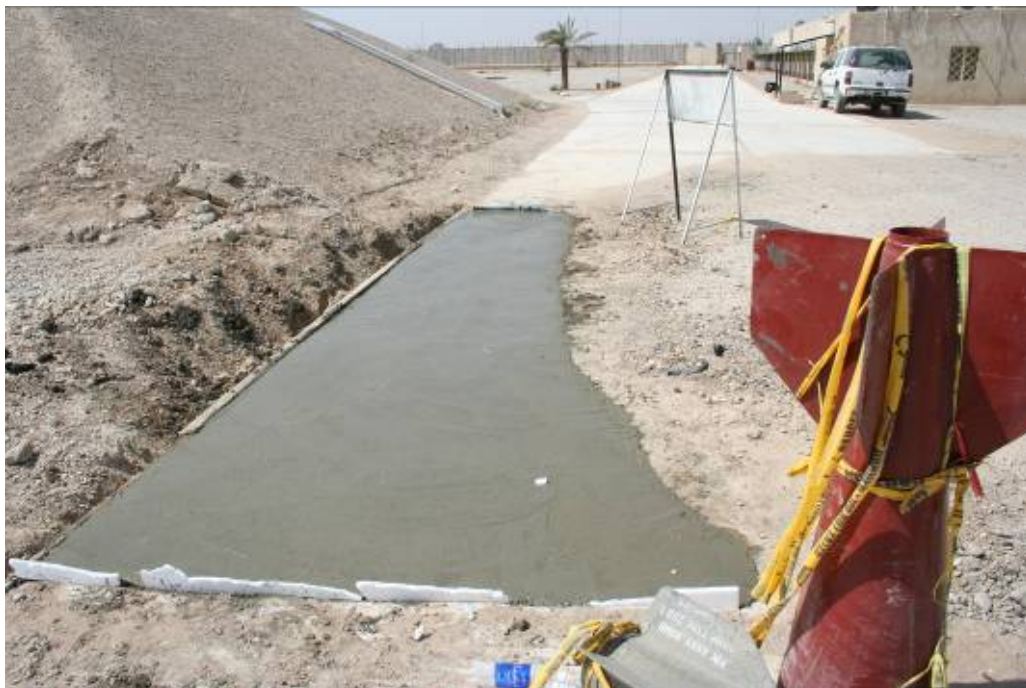
While on site, the assessment team observed that a section of roadway was poured with no hydration until much later in the day. July afternoon temperatures at Al Kut often exceed 110 degrees Fahrenheit. In addition, the team observed that the concrete was not cast to the full thickness of the roadway along the long edge of the casting. Rather, the fresh concrete was layered unevenly over the existing roadway. Site Photo 18 shows the casting just described. Several meters away on the same road, a SIGIR Inspector easily pulled up several pieces of cured cement by hand, without the aid of a tool. The concrete aggregate appeared too large and likely was mixed with an insufficient quantity of water, resulting in concrete that was weak and crumbly. Site Photo 19 shows a piece of concrete removed by hand while Site Photo 20 shows the crumbly nature of the roadway.

Site Photo 18. DBE area roadway.

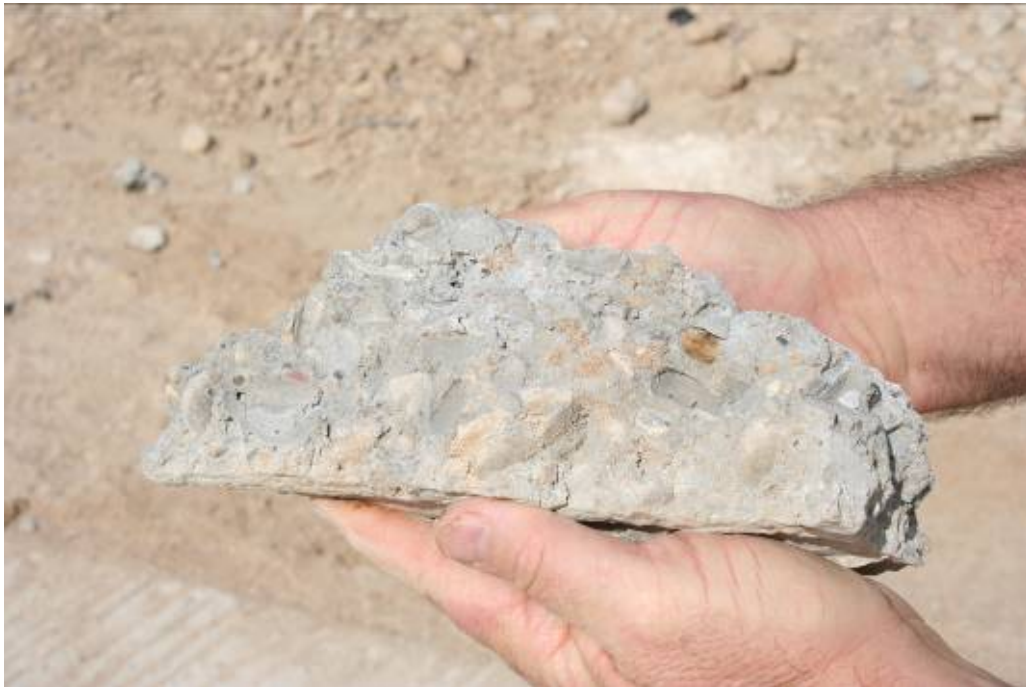
Site Photo 19. Concrete piece pulled from roadway by hand.

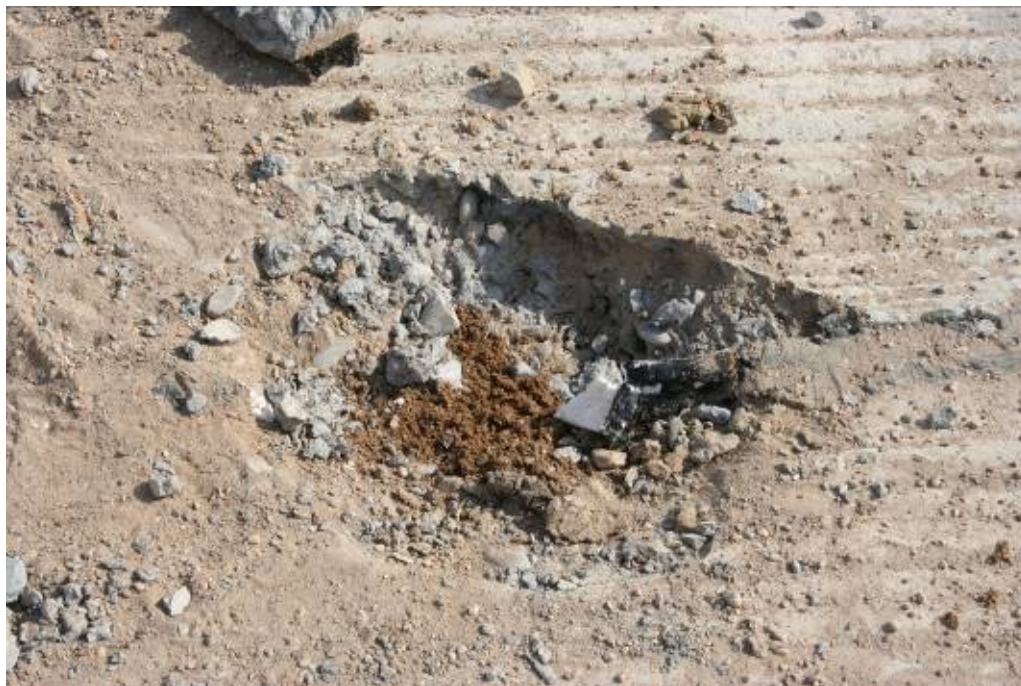
Site Photo 20. Roadway where piece was removed.

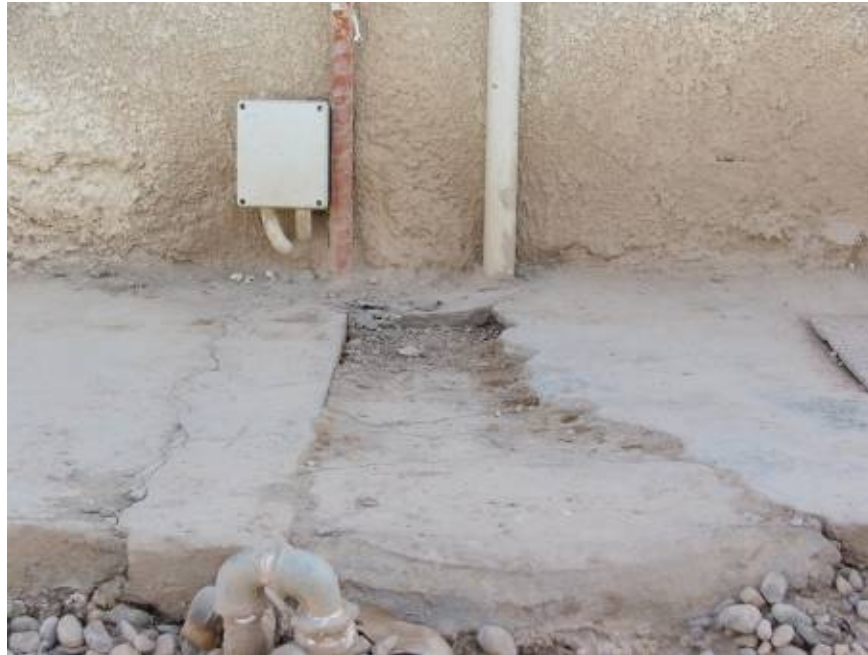
Patchwork installations should conform to applicable flatwork standards in terms of materials and workmanship. The team observed numerous examples of concrete patchwork that was either too thin or placed unevenly and not to code. Site Photo 21 shows an example of such work.

Site Photo 21. Uneven patchwork in Academy HQ sidewalk.

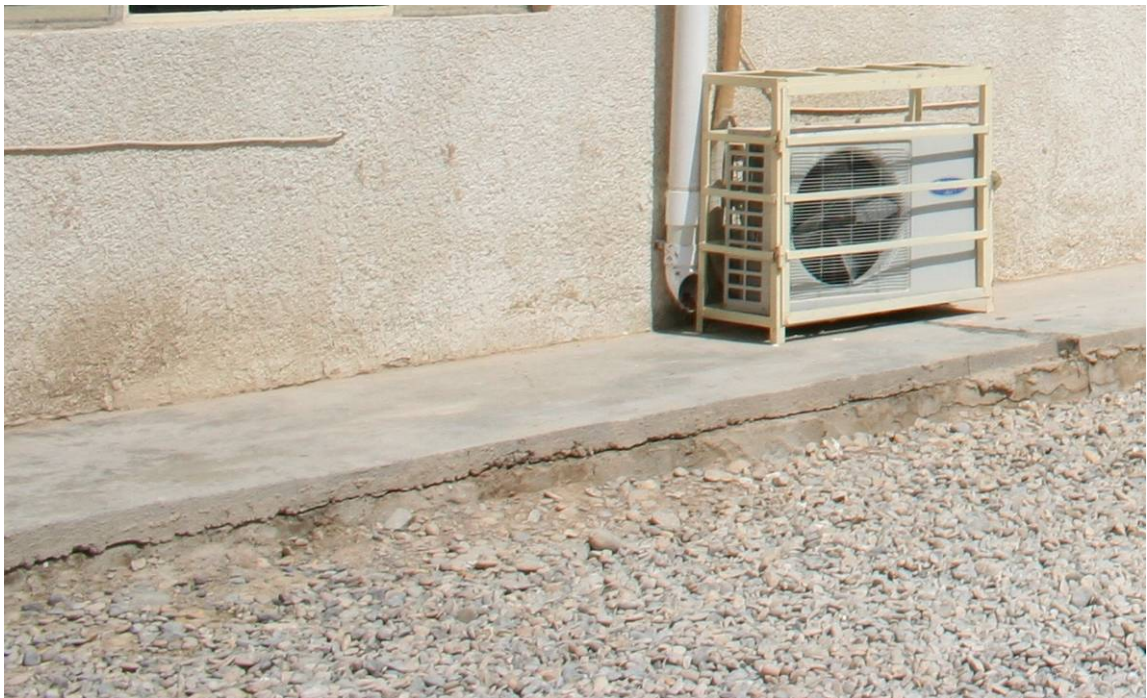
During the site visit, the team observed horizontal fractures that ran along almost the entire perimeter of the newly constructed middle and eastern barracks building foundations. Site Photos 22 and 23 show the described fractures. In addition, similar, but less obvious, horizontal fissures were observed on the second floors of the dormitories.

Site Photo 22. Horizontal fracturing along foundation of middle barracks.

During the assessment, the team was told by the contractor's Project Manager that concrete placement was conducted using small batches mixed by hand. Small hand batch mixing and improper joining techniques could have contributed to the horizontal fractures due to lack of consistency between the numerous small batches mixed by hand. For practicality reasons, each small batch was not subjected to a slump test.

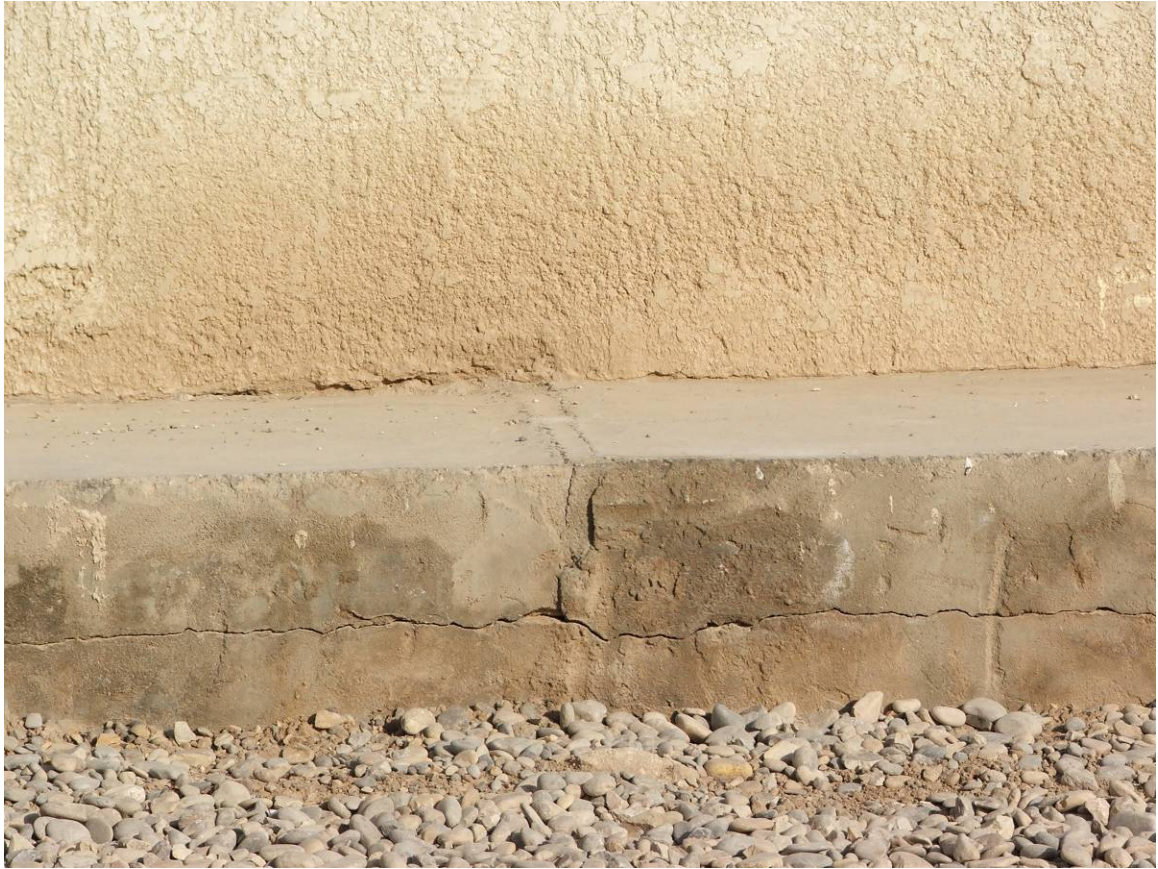
Site Photo 23. East barracks horizontal foundation fracture.

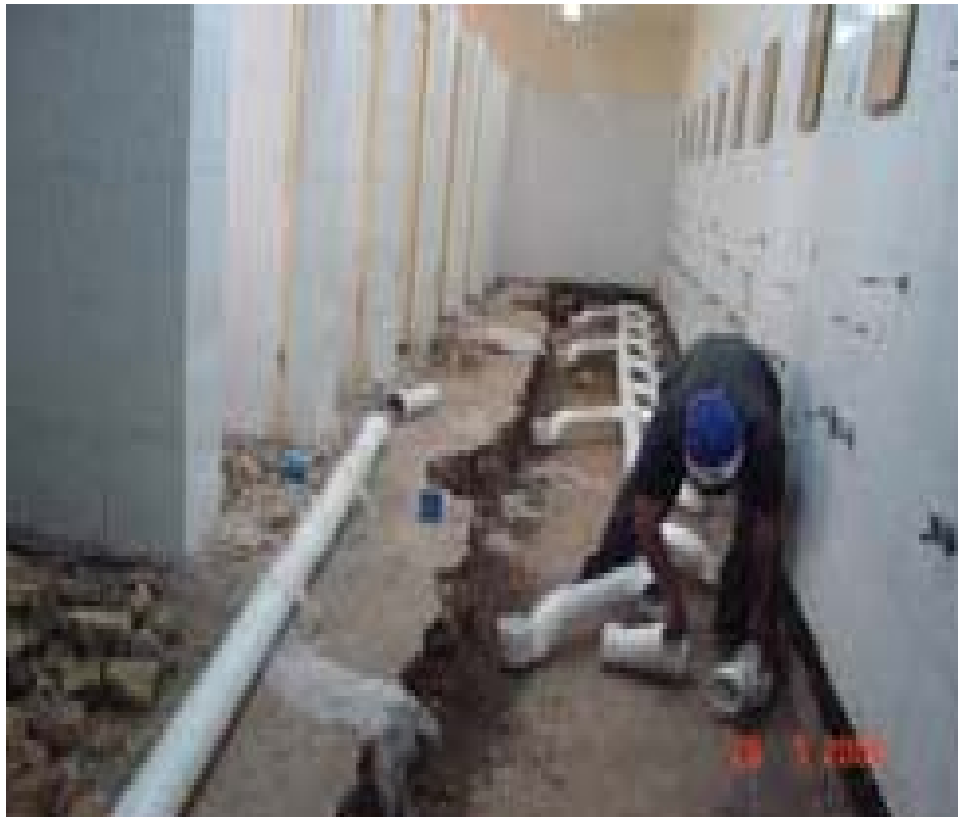
As a result, routine construction deficiencies not detected and corrected as they occurred turned into much larger rework issues. For example, dormitory building D-1 was accepted via DD Form 1354 dated 31 August 2005. However, extensive rework was required within the bathroom to correct the defective construction that should have been detected, monitored, and corrected during construction (Site Photo 24). Specifically, the connections between the smaller diameter feeder drain lines and the larger diameter main drain line system were not water tight because positive connection (glued or threaded) reducers and fittings were not used until the deficiency was corrected in March 2006 (Site Photo 25).

Site Photo 24. Extensive rework in progress (Photo courtesy of ECC).

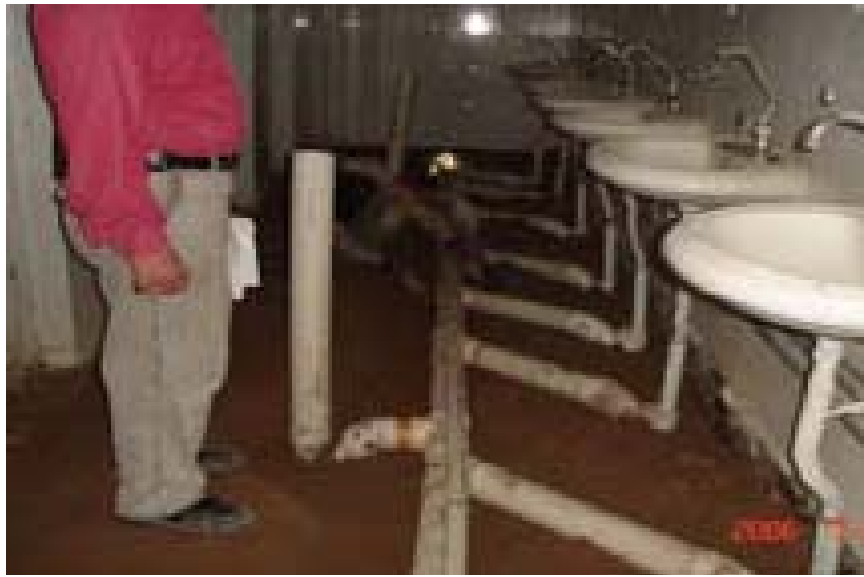
Site Photo 25. Reducers and fittings, before rework, were not water tight (Photo courtesy of ECC).

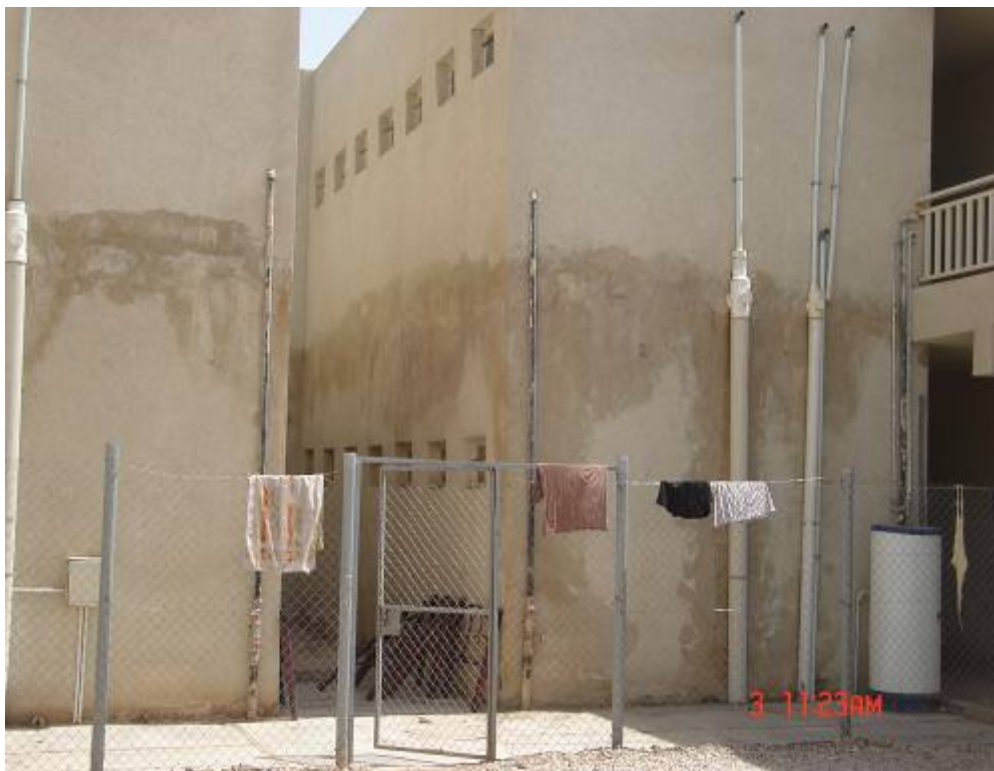
In another very similar example, dormitory building D-4 was accepted via DD1354 on 9 December 2005, but a serious plumbing leak was not reported by QA personnel until 20 April 2006. A photo taken by the government representative on 20 April 2006 shows that substantial water volume migrated subsurface within the second story floor to the outside walls of the building (Site Photo 26).

Site Photo 26. Water stains from improper plumbing (Photo courtesy of ECCI).

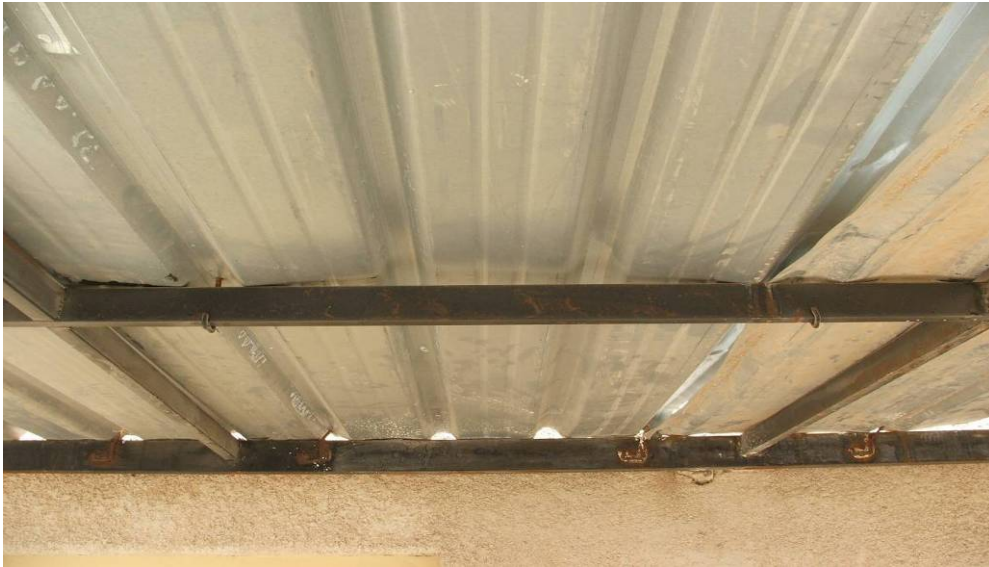
Comparisons of acceptable and not acceptable workmanship for the same task demonstrate the impact of inadequate QM oversight. In the first comparison, the metal roof cover material (Site Photo 27) fastened with too few and improperly located hooks/fasteners to secure the roof cover was compared to properly fastened tin (Site Photo 28) where a fastener was located at tangent points between the tin and the angle iron frame. The second comparison shows water damage to a plywood door improperly hung too close to a wet floor area in a bathroom (Site Photo 29) compared to a door in an adjacent stall properly hung approximately 1" above the floor (Site Photo 30).

Site Photo 27. Tin fastened without sufficient number of fasteners.

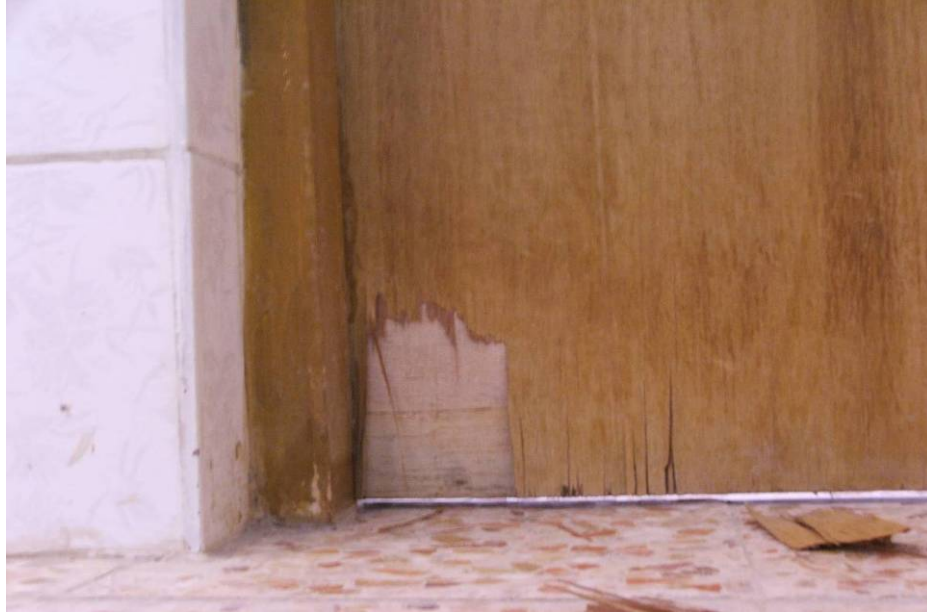
Site Photo 29. Water damaged door installed too close to the floor.

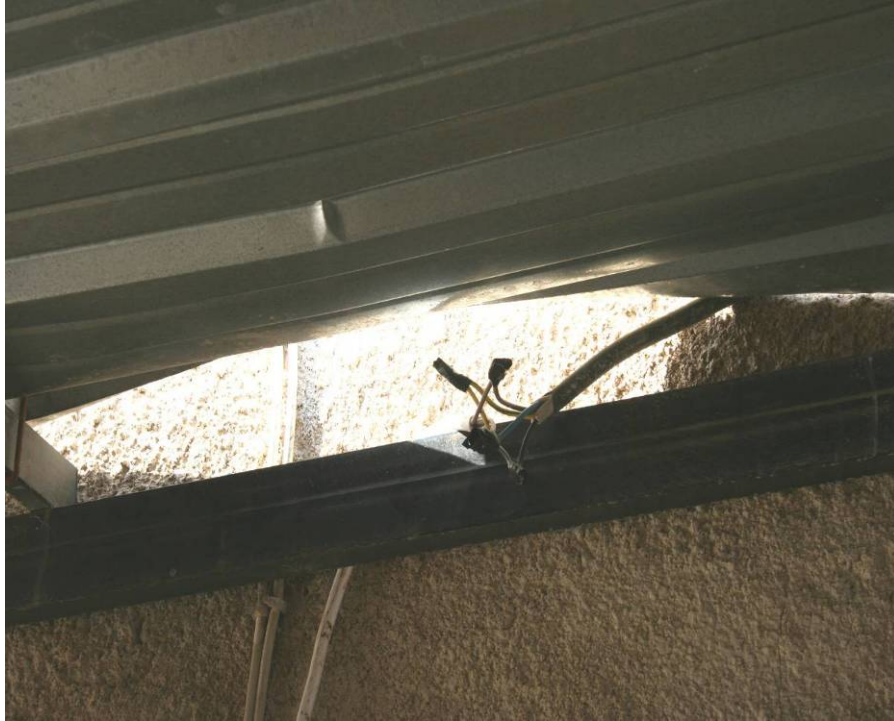
The assessment team observed numerous examples of installations not meeting standards, which if not corrected could lead to significant safety issues. For example, an electric wire splice (Site Photo 31) should have been enclosed in a weather proof box to comply with required codes. In addition, an electric breaker box installed on an exterior wall not sealed from the weather (Site Photo 32) could short-circuit and start a fire or cause serious injury.

Site Photo 31. Unsafe electric wire splice not secured in an enclosed box.

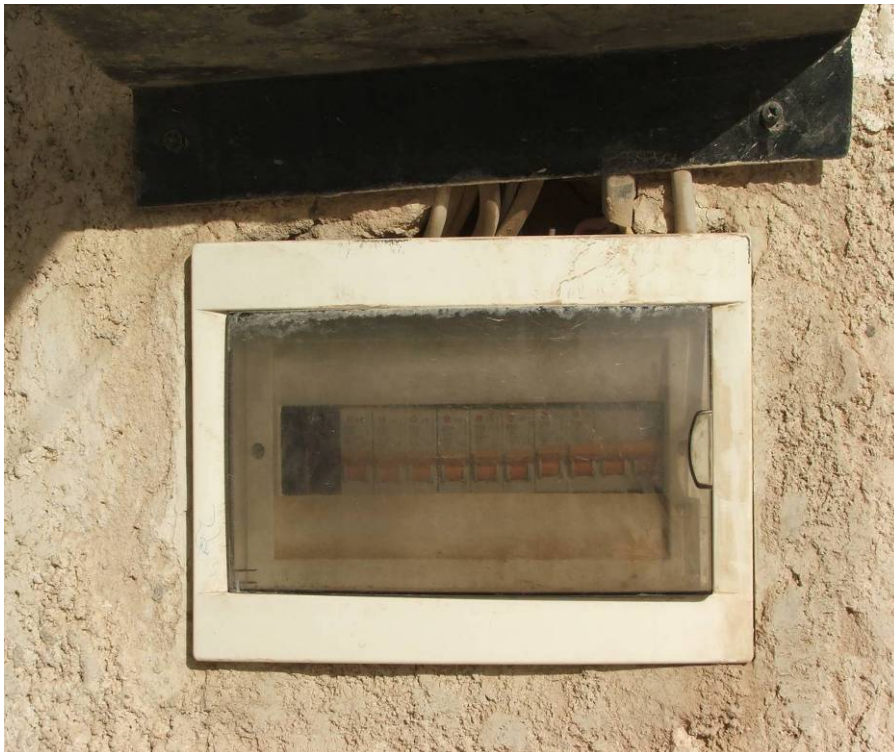
Site Photo 32. Weather exposed circuit breaker box.

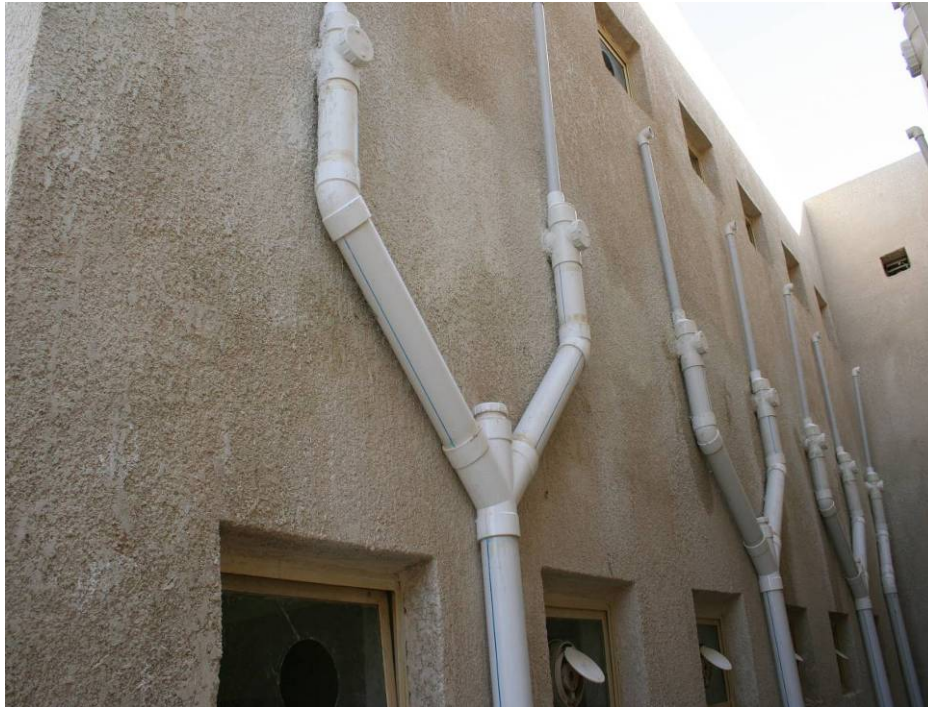
Site Photo 33. Reworked drain lines with upgraded material and improved “Y” design.

recommendation to implement an effective deficiency tracking system or improve related QM procedures. In addition, we verified that the contractor used better materials and an improved drain pipe design when correcting the aforementioned leaks in dormitories D1 and D4 (Site Photo 33).
